TALLIL MILITARY BASE
CAMP UR
NASIRIYAH, IRAQ

SUSTAINMENT ASSESSMENT

SIGIR PA-06-087
SIGIR PA-06-088
APRIL 25, 2007

Tallil Military Base (Camp Ur) Sustainment Assessment Nasiriyah, Iraq

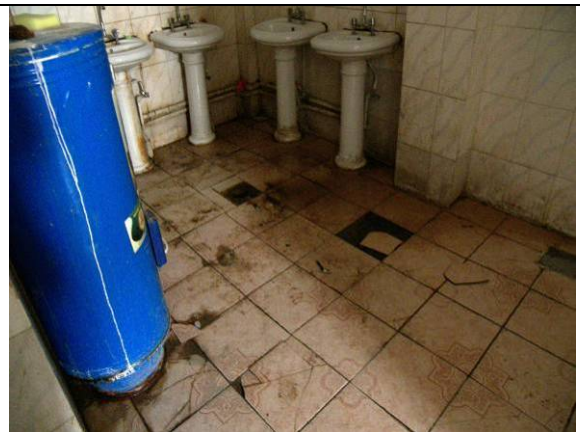
The shortage problem was compounded by using plumbing and fixtures that are closer to household grade than commercial grade. The fixtures, supply lines and valves were flimsy and easily broken after being exposed to the volume of use. Floor tile was installed over a sand base and not adequately sealed. Water seeped through the joints causing tile breakage and damage to the ceiling on the ground level. These problems were also identified during the warranty period where seven of thirty-two work requests involved repairs to bathrooms. Also, during a February 2006 site inspection an AFCEE representative noted eighteen warranty items associated with bathroom floors and fixtures.

Inadequate maintenance and apparent abuse by the occupants further compounded the problem. Un-repaired water leaks damaged floors and ground floor ceilings. Broken fixtures left sinks, showers and toilets unusable. Abusive use such as standing on western toilet seats, slamming shower doors, and stuffing water bottles down toilet drains damaged plumbing and fixtures. These abuses were also noted in an AFCEE representative's site visit report dated 2 February 2006 which cited eighteen examples of soldier abuse to the bathrooms including drains filled with debris, discarded drain covers and cracked toilets. The report commented that the abuse started when the Iraqi soldiers occupied the facility. Site Photos 1 through 7 show the damage to the facilities SIGIR inspected.

Site Photo 2. Bathroom floor and sinks at inspection

1. Although MNSTC-I should insure the barracks' bathrooms have the required compliment of commercial grade sinks, toilets, and showers, undertaking significant corrective action without insuring the facilities will be properly maintained would not be cost effective. Therefore, MNSTC-I should consider delaying corrective action until Operations and Maintenance (O&M) demands are met. MNSTC-I should also determine if the broken air conditioners are warranty issues that should be repaired by the contractor.

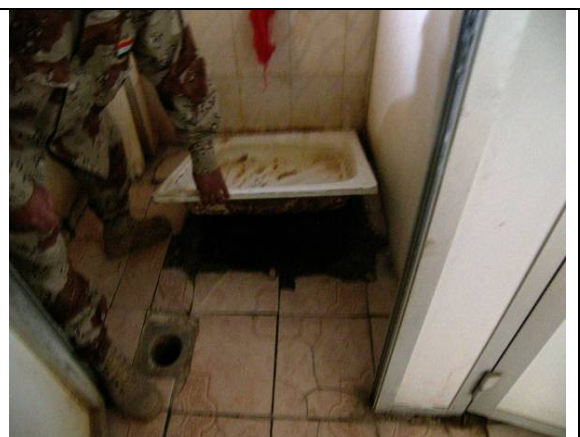
Site Photo 4. Dislodged shower floor pan at inspection

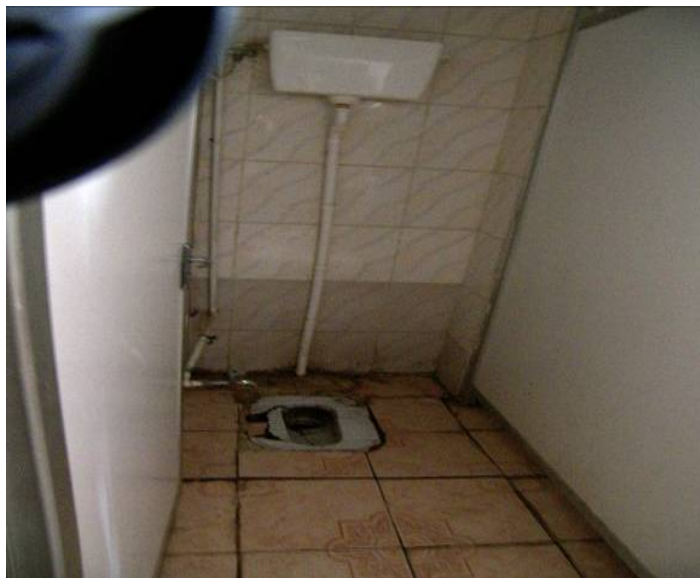
Site Photo 7. Broken eastern toilet

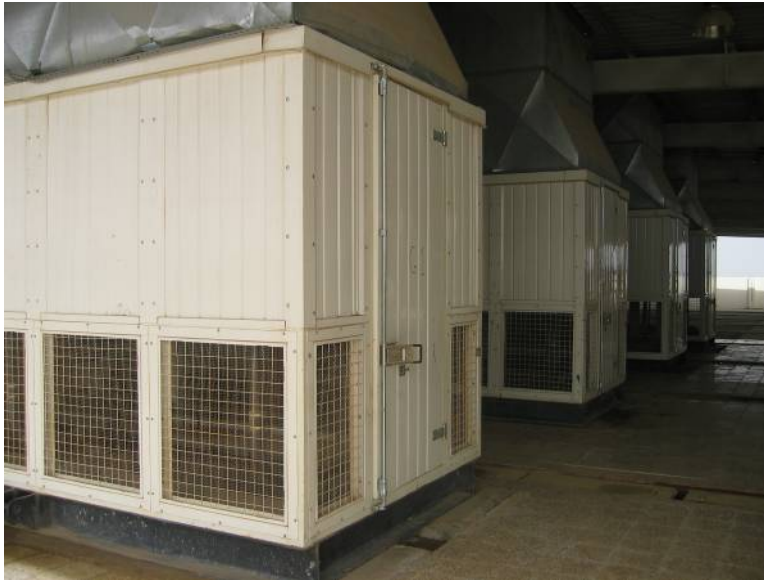
Three of the four remaining generators were operational. The fourth had been waiting for a replacement turbocharger that was ordered in July 2006. The plant manager said that the three generators are sufficient to supply power to the base in the winter but higher demand for air conditioning will pose a problem during the summer. The fourth generator will be needed to supplement power during routine maintenance. The generators were not operating at the time of our inspection due to fuel shortages at the base. The plant manager said the generators operate from ten to

Site Photo 8. Remaining base plant generators.

Recommendation #4 Generator Turbocharger: During a follow-up meeting to clarify its response, MNSTC-I officials noted that they will contact the Base Support Unit at Tallil and offer assistance to expedite the delivery and installation of the turbocharger.

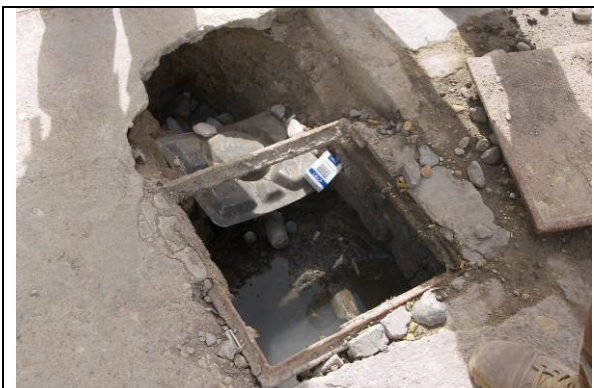
SIGIR's inspection disclosed a number of sidewalks and drain cleanout holes with un-repaired damage from inadequate workmanship and vehicle traffic. The sidewalks and cleanout holes were designed for pedestrian traffic. Quality issues existed at the time the base was delivered to the USG. An AFCEE warranty inspector visited the site on February 2 and 3, 2006 and noted that approximately 70% of the concrete work done on sidewalks was of poor quality and would need to be replaced.

Site Photo 9. Broken drain cleanout hole

2. MNSTC-I should review the sidewalk and storm drain conditions and determine if they are still covered by the warranty. If the sidewalk damage is covered under the warranty, the contractor should be required to make the necessary repairs. If the warranty is void due to vehicle damage, MNSTC-I should either fund the repair or notify the GSU that they are responsible for repairing the damage.

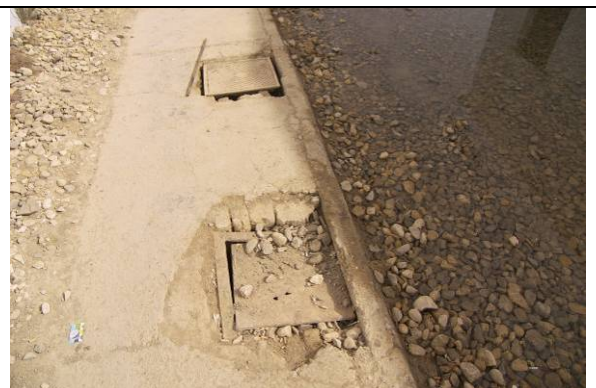
Site Photo 10. Drainage cleanout holes and standing water that should drain into the system
